Wood boring insect

Anobium Punctatum

Information Sheet

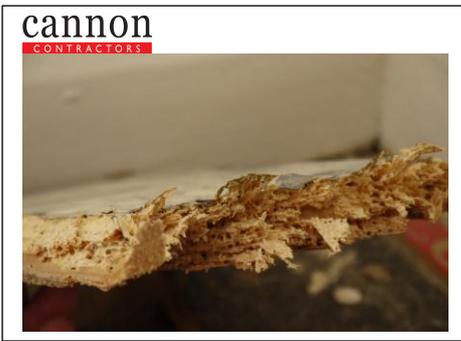
Floorboard showing the effects of woodworm

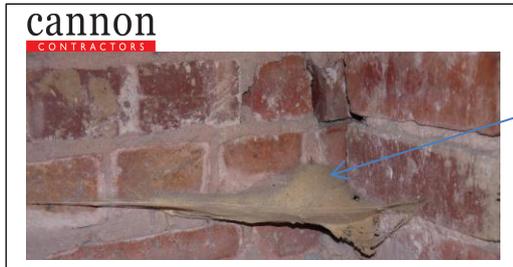
The web catching the *frass*, and not a fly!

Whilst the exit holes on the timber are a clear indication of an attack, generally it's the byproduct of an attack that is an easier visual indicator that an attack is occurring. This substance is called *frass* and is like sawdust and in cellars is often falls and deposits in spiders webs

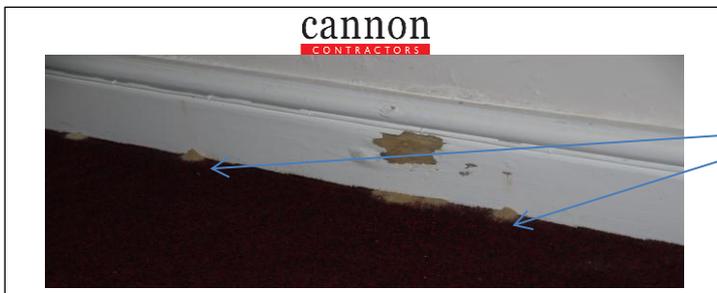
Here you can clearly see the *frass* deposited on the carpet that has formed small piles as the adult has left the skirting board.
